METALLOGRAPHY OF NON-METALLIC INCLUSIONS IN PIPE METAL AND IMPACT ASSESSMENT OF DEFECT STRUCTURES ON NON-DESTRUCTIVE TESTING OUTCOMES

D. V. Zhukov^{1,2}, S. V. Konovalov¹, A. A. Melnikov³, Danhe Chen¹

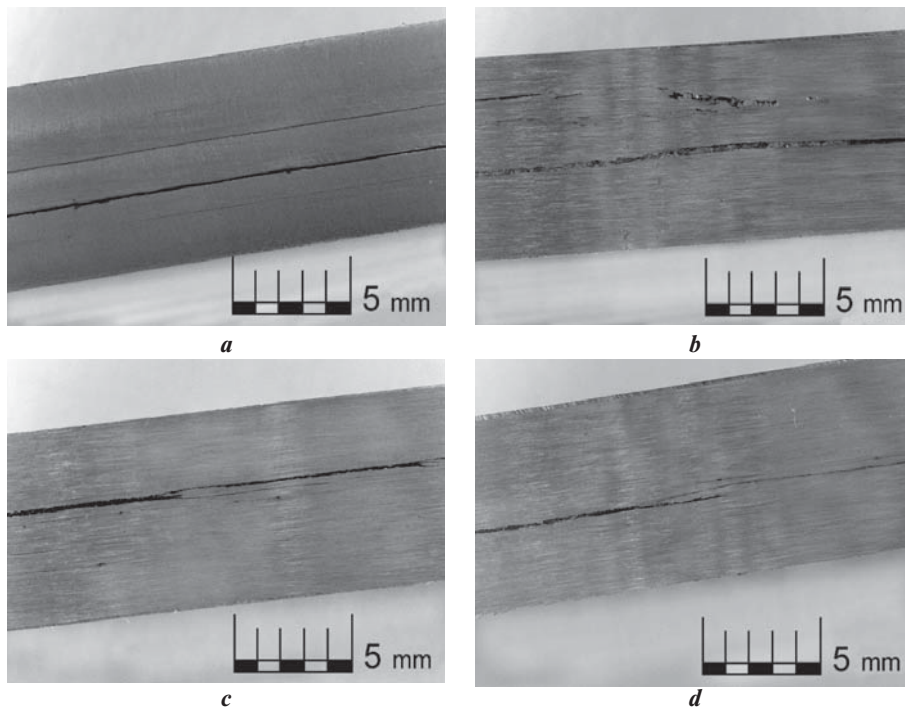
When inspecting a side surface of samples, planar inclusions in a pipe wall were visible to unaided eye or under insignificant magnification (**fig. 1**). The thickness of the widest light yellow to green inclusion was as much as 1.0 mm.

Fig. 1. A section of a pipe wall with planar inclusions of various number, position and thickness: *a* — a zone with three extended layers of inclusions; *b* — a zone with extended longitudinal inclusion and not-extended inclusions with a variety of forms; *c* — a branched extended inclusion; *d* — a branched extended inclusion with the variable thickness

similarly to the most typical lamination pattern caused by the dendrite liquation. However, inclusions found in the majority of samples divided a pipe wall into several layers (fig. 1 *a, b*), demonstrated other volumetric and planar defects (fig. 1 *b*), and were displaced towards the outer (fig. 1 *c*) or inner (fig. 1 *d*) pipe surface. Most inclusions with parallel line-type or short planar incorporated objects (fig. 1 *b*) were located not on the axis of a pipe wall. Furthermore, some inclusions were branched when propagating, penetrating into another layer or forming several parallel stripes (fig. 1 *c, d*). The gap between inclusions was in a range from 0.1 to 2 mm. The inspection of the pipe revealed a defect zone occupies approximately 40 % of the perimeter and fails to meet the requirements [22] for area, extension and cross impact of defects.

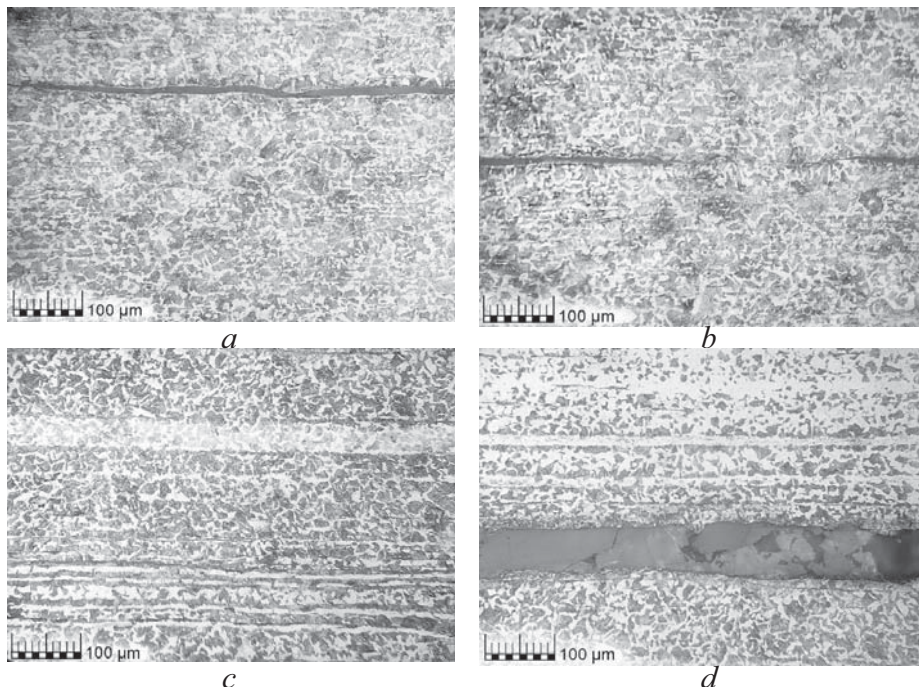
Fig. 2. Discontinuities and structural characteristics of a pipe wall: *a* — extended inclusions with the thickness of 10 μm; *b* — broken inclusions with the thickness up to 5 μm; *c* — layered metal structure with ferrite and pearlite layers; *d* — extended inclusions with the thickness up to 1 μm

The visual inspection has provided more details of extended longitudinal cracks. Additionally, thinner discontinuity zones of a variety of lengths were detected in the base metal. The base metal had a ferrite and pearlite crystal structure with the explicit anisotropy of rolling (fig. 2).

The study has revealed several carbon-free zones around rolled inclusions in some samples; a number of samples demonstrated a layered structure with incorporated ferrite layers (fig. 2 *c, d*). The structure of rolled inclusions is extended, dot-type and lengthy. Some samples show the grain heterogeneity and different relation of pearlite and ferrite percentages (fig. 2 *c, d*). The width of inclusions varies in a wide range from 0.1 μm to 1 mm. Inclusions are found nearly throughout the entire pipe wall thickness, forming defective zones with the total width up to 5 mm. Besides a distinct stripe-like structure typical for the rolled steel there are layers with irregularly distributed ferrite and pearlite in defect zones of samples. A guideline to evaluate a degree of the strip-like structure and the orientation of microstructures is given in [27], however, they are not considered as an intolerable flaw in pipes, indicating only a manufacturing flow deviation.

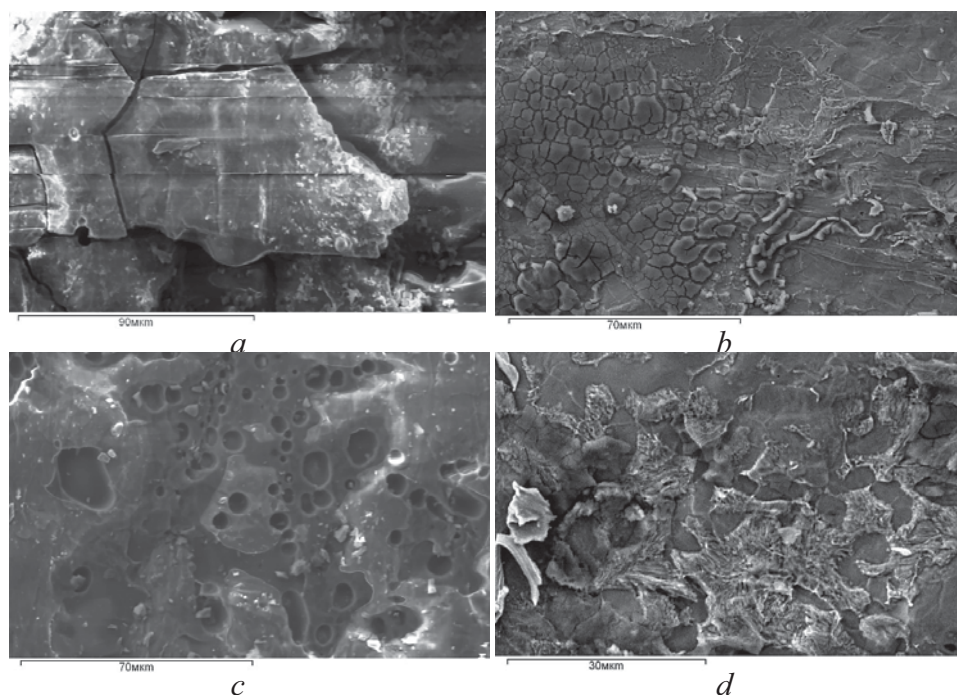
An X-ray microanalysis of defective zones was carried out. The chemical composition of steel and lamination products was determined. The study was also focused on structural differences in defective zones (fig. 3).

Several basic inclusions constitute the chemical composition of sample surfaces in defective zones (Tabl. 2). An analysis of spectra in laminations has disclosed fragments of charge materials, e.g. the presence of fluorine and calcium evidences there is not dissolved fluorite (calcium fluoride, CaF_2 in the metal) used as a flux in melting furnaces. Main inclusions are found to be aluminum oxide (Al_2O_3) and silica glass (SiO_2),

Fig. 3. X-ray microanalysis of the defective zone:

a — brittle glassy inclusions; *b* — zones with signs of high-temperature impact; *c* — inclusions without explicit cracking; *d* — surface with partially removed bloom

which are components of broken bricks used instead of a certain amount of fluorite. The research into the chemical composition spectra has revealed a small amount of complex iron and manganese silicates ($n\text{FeO} \times m\text{MnO} \times p\text{SiO}_2$). Some laminations contain the rolled slag (FeO , Fe_3O_4 , Fe_2O_3), formed in shrinkage holes and gas bubbles. An amount of sulphur (S) — the most important element for the dendrite liquation is insignificant and detected in one sample only.

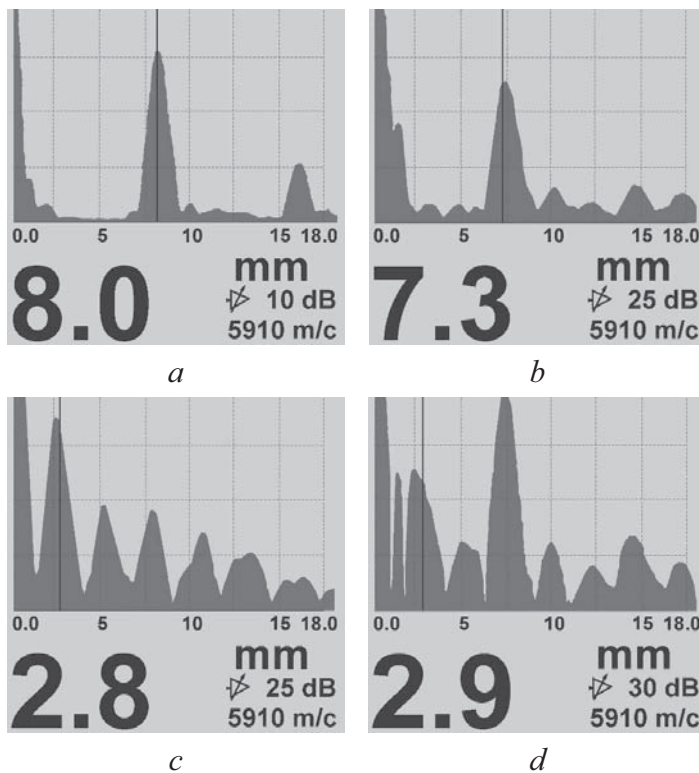
Fig. 4. Outcomes of ultrasonic measurements:
a — readings recorded on a defect free sample with the thickness of 8 mm; *b* — readings on a pipe wall in a defect free zone; *c* — readings on the defective zone with the thickness more than 200 μm ; *d* — readings on the defective zone with the thickness less than 100 μm

The ultrasonic measurements carried out on defective zones have revealed a relative dependence of their findings upon thickness of inclusions. As surfaces are not even, the composition and density of dislocations are different, it is hardly possible to determine accurately the exact thickness of inclusions when ultrasonic testing. However, from the measurements carried out on cut out samples it is apparent that separate dot-type and not extended inclusions with the thickness of less than 5 μm , rolled ferrite stripes and zones displaying a dissimilar pearlite and ferrite structure hardly influence the readings. Inclusions up to 15–20 μm form a semi-transparent environment for an ultrasonic wave, which weakens a back wall signal (fig. 4 *d*), although the signals from several reflective layers are observed on the screen: from a defective area and a bottom wall of a pipe. In most cases these signals are similar to those of liquation zones and zones with partially welded laminations. Extended inclusions thicker than 20 μm represent a nontransparent block for an ultrasonic wave (fig. 4 *c*), so it is not possible to measure the exact thickness of the product.

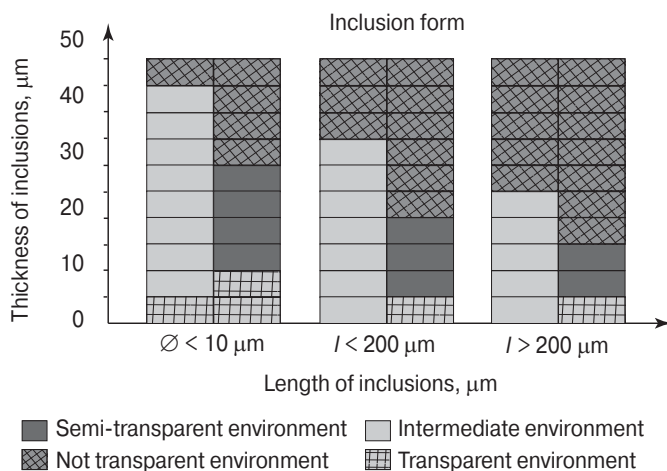
Fig. 5. Effect of inclusions on the ultrasonic testing results

In light of conducted measurements we detected the regularity and tabulated the data on the relation between thickness and form of extended inclusions and discontinuities on readings of the thickness measuring device (fig. 5).
