## LASER SCANNING-BASED TRUE CONDITION OF MINE SHAFT

The article presents SLAM CHCNAV RS10 scanner data obtained in 2025 in an operating mine shaft. The list and execution speed of operations are reported, and the data interpretation is given. The processing order of the point cloud and the condition analysis of the test mine shaft are described. It is for the first time found that laser scanning determines many required parameters and characteristics which ensure safety, efficiency and facilitation of mining operations, namely: true condition and serviceability of operating mine openings; damage spots in support and lining, including visually unobservable areas; solid mineral output capacity both in open pit and underground mining; parameters of support and reinforcement in mine openings; rock mass stability, alignment of stopes and pillars; excessive volume of rock haulage per 1 m of stoping in case of increased design section of stopes, etc. Laser scanning with SLAM CHCNAV RS10 simplifies survey measurements and enhances efficiency of deformation monitoring. Periodic scanning of stopes exhibits deformation trends, high stress-strain areas in support and reinforcement system of

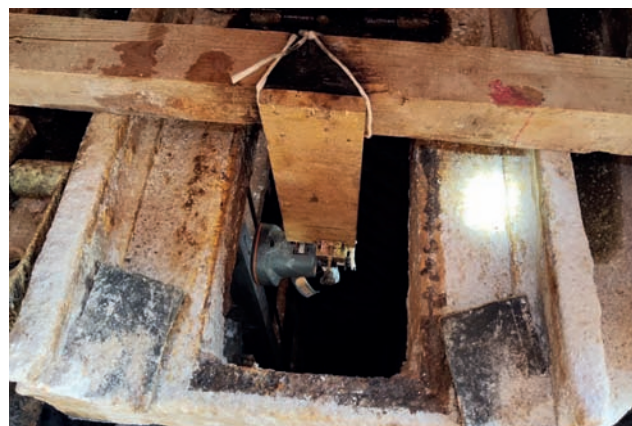
The study aimed to assess the actual condition of a mine shaft to understand its further reconstruction and operation options [8–11]. The shaft scanning was carried out by 2 workers for 2 days, and the data were processed and interpreted within 2 weeks. SLAM CHCNAV RS10 scanner was arranged under the cage floor, at the bottom of the inspection window (Fig. 1). It was decided to be inexpedient to set the scanner above the cage because of water entry in the shaft and owing to periodic rock falls.

Fig. 1. Arrangement of SLAM CHCNAV RS10 scanner beneath the cage

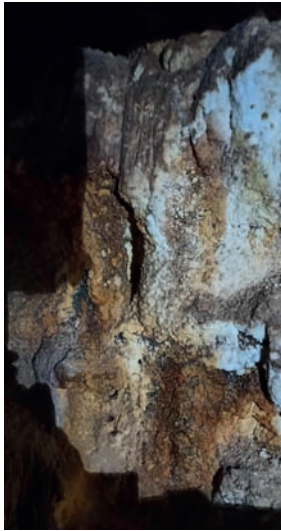
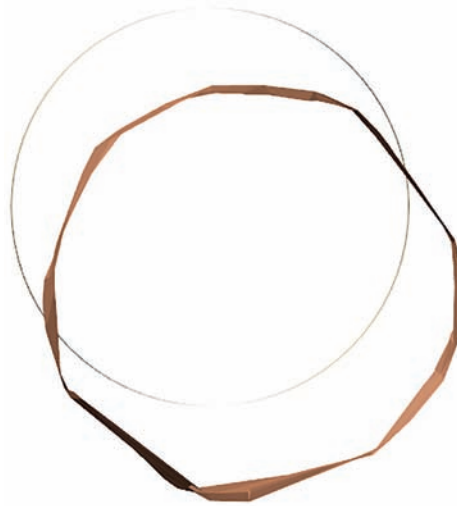
Fig. 6. Fracture in cast-iron tubing (level 88–89 in the shaft) and horizontal section at level 88 at elevation –145.275 m

The horizontal section of the vertical roundness shaft with the diameter of 4.5 m with regard to the inclination is marked with the grey color circle, and the actual frame of the shaft is colored in orange.

At the levels of –100.46, –105.191, –108.54 to –130.174 and –142.276 to –151.264 m in the west wall of the shaft, cracks are recorded in the tubing and fracturing zones are predicted (Figs. 6 and 7a).

1. The tubing support breaks in the sites intersected by the focal or by the shorter axes of the shaft cross-section ellipse due to the change in the physical and mechanical properties of the tubing material because of the metal corrosion and ageing for over 60 years. The tensile cracks at the intersections by the shorter axes are visually seen, while the tensile cracks at the intersections with the focal axis are visually unseen as they appear on the back side of the lining.
